EXHIBIT G

May 9, 2019

Re: *Susman, et al. v. The Goodyear Tire & Rubber Company*

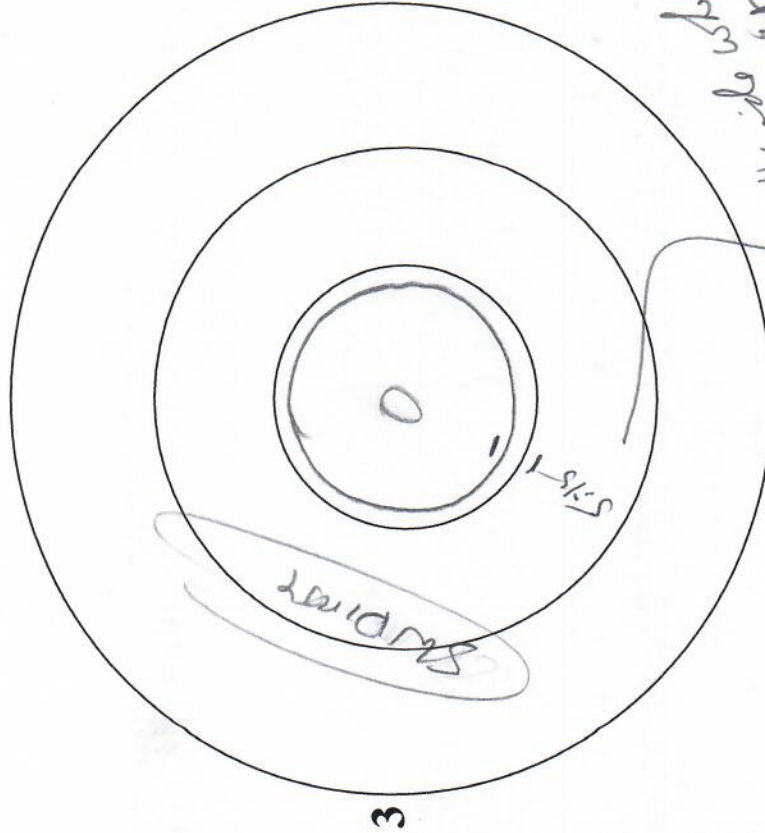
SIZE: LT 235/85R16 MAS

- 1) Tread + Top Steel Belt Detached + Missing from ~4:00 SS/6:00 OSS to ~10:30 SS/12:30 SS.
- 2) Tread + Top Steel Belt Partially Detached from ~10:30 SS/12:30 SS to ~1:00 SS/12:45 SS where still attached. SS Top Belt cord ends from ~10:30 SS to ~11:00 SS are loose, bare, rusted, bent + frayed.
- 3) Overall, Steel Belt cords adhered in Rubber, Exposed Steel Cords rusted.
- 4) Rubber remaining over bottom Steel belt in detached region in crown is worn with lateral abrasion.
- 5) 11:30 crown 4 Broken Bottom Steel Belt Cords/filaments
- 6) Multi level Rubber tearing on all detached surfaces. Radial Multi level Tear lines along SS + OSS Bottom Belt edge in detachment region.
- 7) A few permanent bends in bottom steel belt in detachment region.

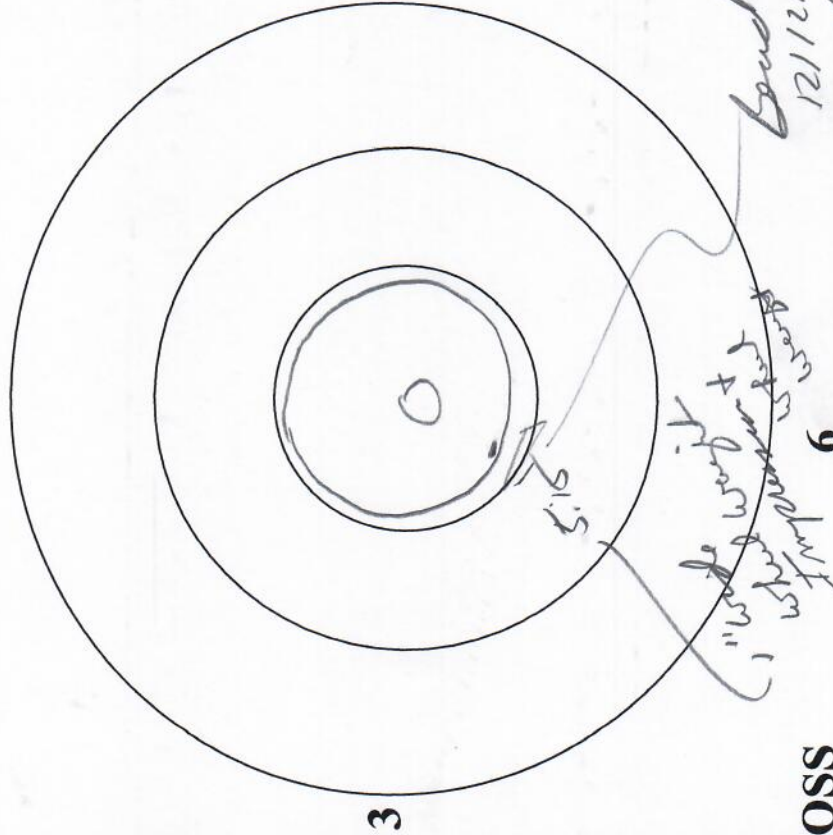
1) WORN POLISHED FLANGES
